AXIAL BEHAVIOUR OF REINFORCED CONCRETE FILLED STEEL TUBE STUB COLUMNS WITH PERFORATIONS EXPOSED TO FIRE

S. Lokesh¹, R. Siva Chidambaram^{1,2}

⁽¹⁾ Academy of Scientific and Innovative Research (AcSIR), Ghaziabad 201002, India

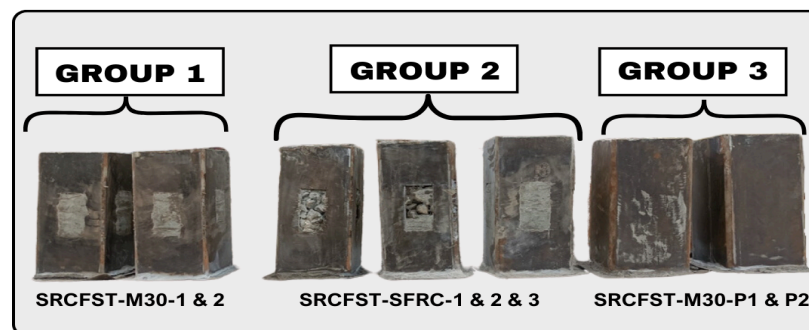
A total of seven SRCFST stub columns with reinforcements were fabricated and categorized into three distinct groups based on the presence of perforations and the type of concrete used listed in Table 1 (M30 and SFRC). Figure 2 shows the CFST stub column specimens after casting. All columns had a square cross-section with dimensions of 150mm x 150mm x 300mm.

Figure 2 Stub column specimens casted

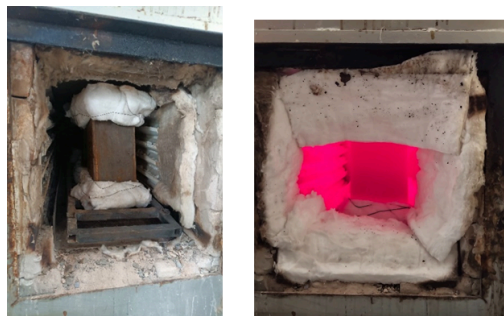
Figure 4 shows the fire exposure of CFST specimens inside the furnace. Following this high-temperature exposure, a controlled cooling phase was initiated within the furnace. The controlled cooling process was carefully managed to prevent rapid thermal gradients, which could introduce additional stresses and alter the structural behavior of the specimens [6]. This experimental approach provides valuable insights into the fire resilience of these composite columns and is fundamental for developing effective design guidelines and fire safety standards for structures incorporating SRCFST columns.

Figure 4 Fire exposure of CFST specimens in furnace

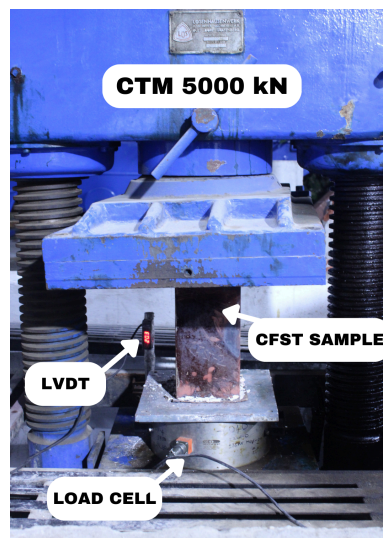
The experimental testing was carried out using a Compression Testing Machine (CTM) with a capacity of 5000 kN to evaluate the axial behavior of the SRCFST column specimens. The columns were placed vertically in the CTM, ensuring proper alignment to prevent eccentric loading, as depicted in the experimental setup shown in Figure 5. A Linear Variable Displacement Transducer (LVDT) was used to accurately measure the axial displacement of the columns throughout the loading process. The load was applied at a constant rate, and the testing continued until the axial load capacity of the specimen dropped below 65% of its peak value. This systematic approach enabled a detailed assessment of the structural response and failure characteristics of the SRCFST columns under compressive loads.

Figure 5 Experimental view of the test setup

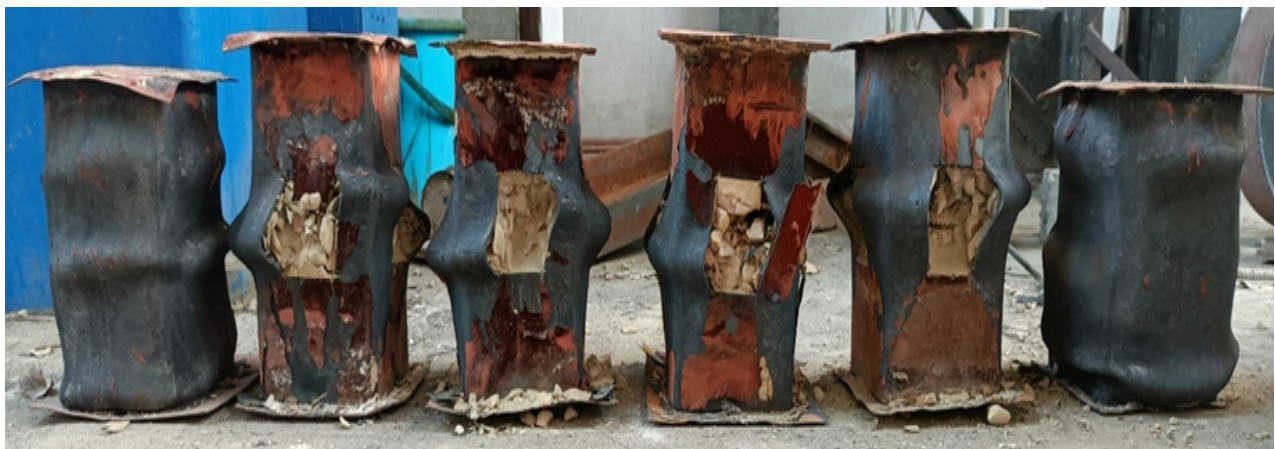
The failure modes of the SRCFST column specimens varied depending on the presence of perforations and the type of concrete used. Figure 6 shows the failure modes of the CFST specimens.

Figure 6 Failure modes of column specimens

- 1. SRCFST-S-M30-1 and SRCFST-S-M30-2:** These non-perforated columns cast with M30-grade concrete displayed typical failure characteristics of SRCFST columns under axial compression. The failure was primarily characterized by outward buckling of the steel tube, followed by crushing of the concrete core [7]. Outward buckling of concrete

was also observed during testing. The steel tube provided confinement to the concrete, delaying the onset of significant cracks until higher loads were applied. The columns maintained structural integrity until reaching their peak load capacities of 1136 kN and 1261 kN, respectively.

2. **SRCFST-SFRC-P3:** The control specimen with SFRC (Steel Fiber Reinforced Concrete) and without perforations exhibited a similar failure pattern. The steel fibers enhanced the concrete's tensile strength, leading to more ductile failure [8]. The column showed signs of concrete spalling and localized buckling of the steel tube. The peak load capacity was 1164 kN, slightly higher than the M30 concrete specimens, attributed to the improved properties of SFRC.

1. **SRCFST-M30-P1 and SRCFST-M30-P2:** The M30 concrete specimens with perforations on all four faces exhibited premature failure due to stress concentrations around the perforation zones. The presence of perforations reduced the confining effect of the steel tube, leading to early local buckling and cracking of the concrete. The failure was characterized by significant deformation near the perforations and spalling of concrete, resulting in lower peak load capacities of 773 kN and 643 kN, respectively.

2. **SRCFST-SFRC-P1 and SRCFST-SFRC-P2:** These specimens, made with SFRC and perforations on all four faces, demonstrated a more gradual failure compared to the M30 specimens. The steel fibers helped to bridge the cracks and provided additional tensile strength, delaying the onset of failure. However, the presence of perforations still caused stress concentrations, leading to localized buckling and spalling of concrete around the perforation areas. The peak load capacities were 862 kN and 854 kN, which were higher than the perforated M30 columns but lower than the non-perforated SFRC control specimen.

1. The SRCFST stub columns with perforations exposed to fire demonstrate different failure modes when compared to control specimens without fire exposure. The local failure of the specimens was early, and outward buckling at the top and bottom of the stub column was observed for specimens exposed to fire. The effect of perforations in the specimens was observed as the perforations reduced the confining effect, which led to cracks and buckling of steel tube near the perforation zone.
